WATERSHED-BASED MANAGEMENT PLAN

GOOSEFARE BROOK WATERSHED

May 2016

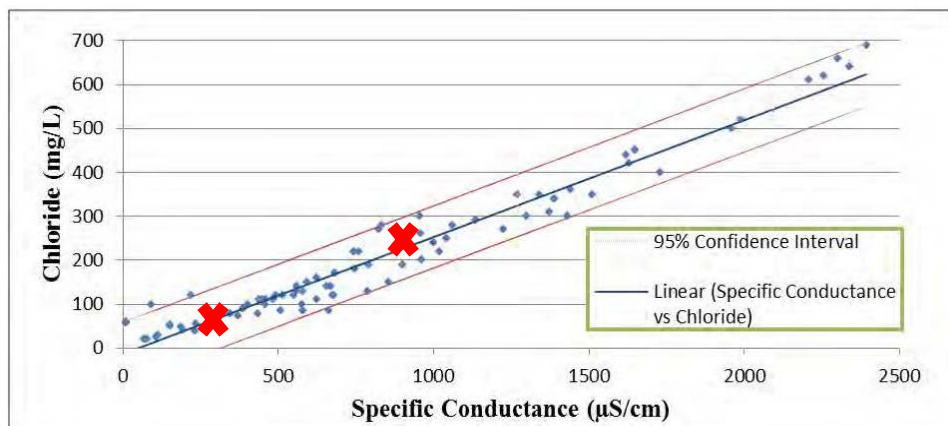
Figure 6. The specific conductance versus chloride relationship created from the Long Creek Watershed aggregate data. Red 'x' indicate where Goosefare Brook samples fall. SOURCE: Long Creek Annual Monitoring Report June 2010 to November 2011.

In 2015, the Maine DEP measured both SpC and chloride from water samples taken at two stations along Goosefare Brook to identify if SpC and chloride adhered to the chloride-conductivity relationship established for other Southern Maine streams. On September 8, 2015, DEP staff measured a SpC of 860 $\mu\text{S}/\text{cm}$ in Goosefare Brook (S-271) and laboratory analysis found the associated water sample to have a chloride level of 240 mg/L. Furthermore, a SpC of 256 $\mu\text{S}/\text{cm}$ (SGSBRUA07) was correlated with 54 mg/L measured chloride which follows the established curve and indicates that SpC values over 800 $\mu\text{S}/\text{cm}$ are approaching toxic levels (Figure 6).

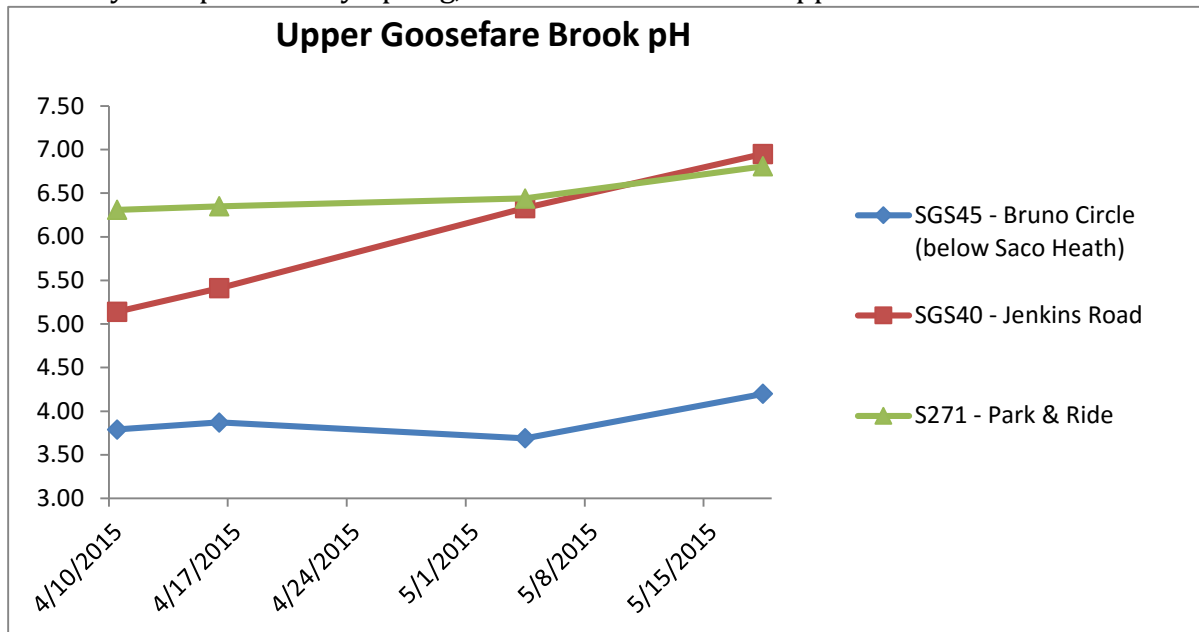
Figure 7. A summary of pH data available for Goosefare Brook from the Maine DEP.

could be a stressor for aquatic life in the headwaters of Goosefare Brook, especially when low pH water flushes out of the heath in early spring led the Maine DEP to conduct sampling in early spring 2015 at three stations: Bruno Circle (SGS45), Jenkins Road (SGS40) and Park and Ride (S-271). Bruno Circle readings were consistently very low (<4.5), however, pH values appear to recover before the Park and Ride station (Figure 7). Organisms at the Jenkins Road station could be impacted by low pH in early spring, but these values also appear to recover later in the season.

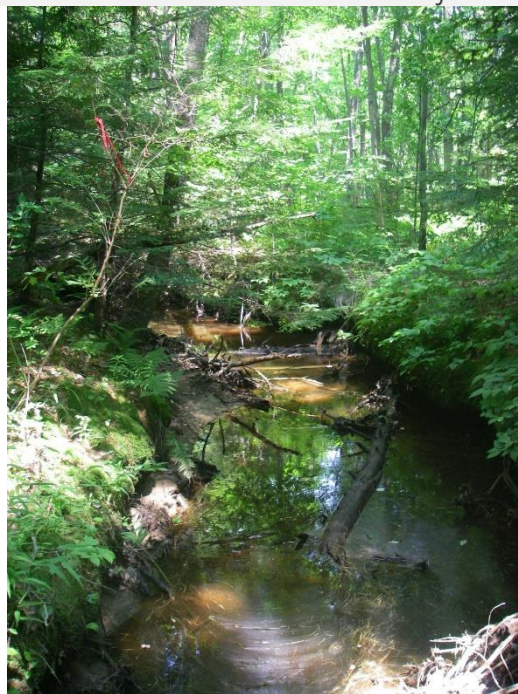
Shaded stream channels help reduce temperatures in freshwater streams.

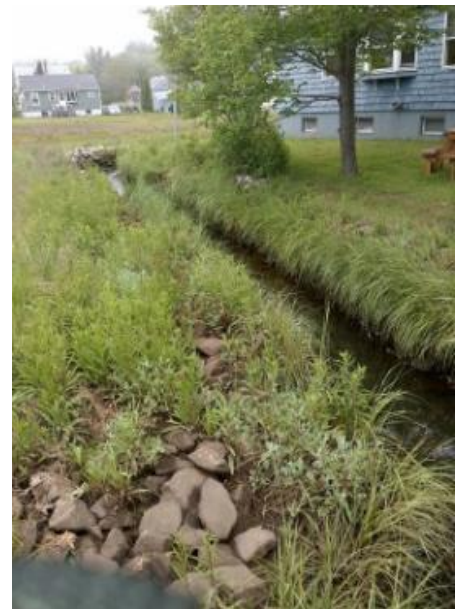
An altered stream channel found during the 2015 Stream Corridor Assessment. PHOTO

Stream channel alterations include any human-made changes to the stream course or channel shape (such as straightening or widening the stream). Alterations can also include additions of dams, retaining walls, or other channel armoring. Such structures and alterations can block fish passage, impair stream habitat, slow down stream flow, and create channel instability. Eleven channel alteration sites were identified in the SCA survey and another three problem sites were identified by the geomorphic assessment (Appendix I, Map M; Appendix III, Table 10). The geomorphic sites are discussed in a subsequent section. The remaining eleven sites included six sites where the stream had been straightened and armored with riprap; two sites with riprap on the stream bottom creating an impoundment; two historic structures adjacent to the stream; and one collapsed concrete culvert. The straightened and riprapped stream segments create geomorphic and habitat issues; however, restoration could be challenging due to the proximity of roads and other infrastructure.

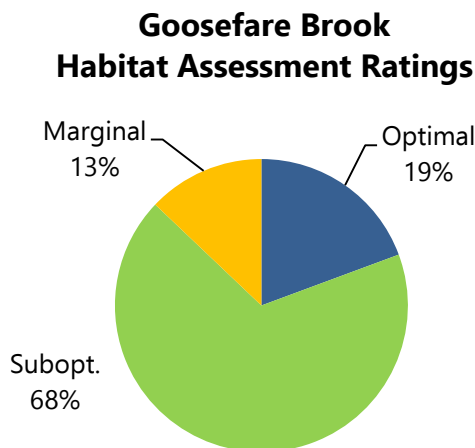
Figure 9. Habitat Assessment Ratings from the Stream Corridor Assessment.

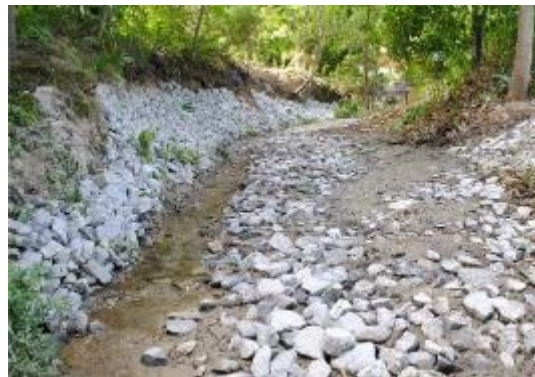
Examples of findings from the RGA, bank armoring at Upper Bear Brook. PHOTO CREDIT: John Field (see Field 2015)
