# APPENDIX I: Relevant Maps of the Goosefare Brook Watershed

# STORMWATER/SEWER INFRASTRUCTURE Goosefare Brook

## APPENDIX II: Supplemental Water Quality Data and Figures

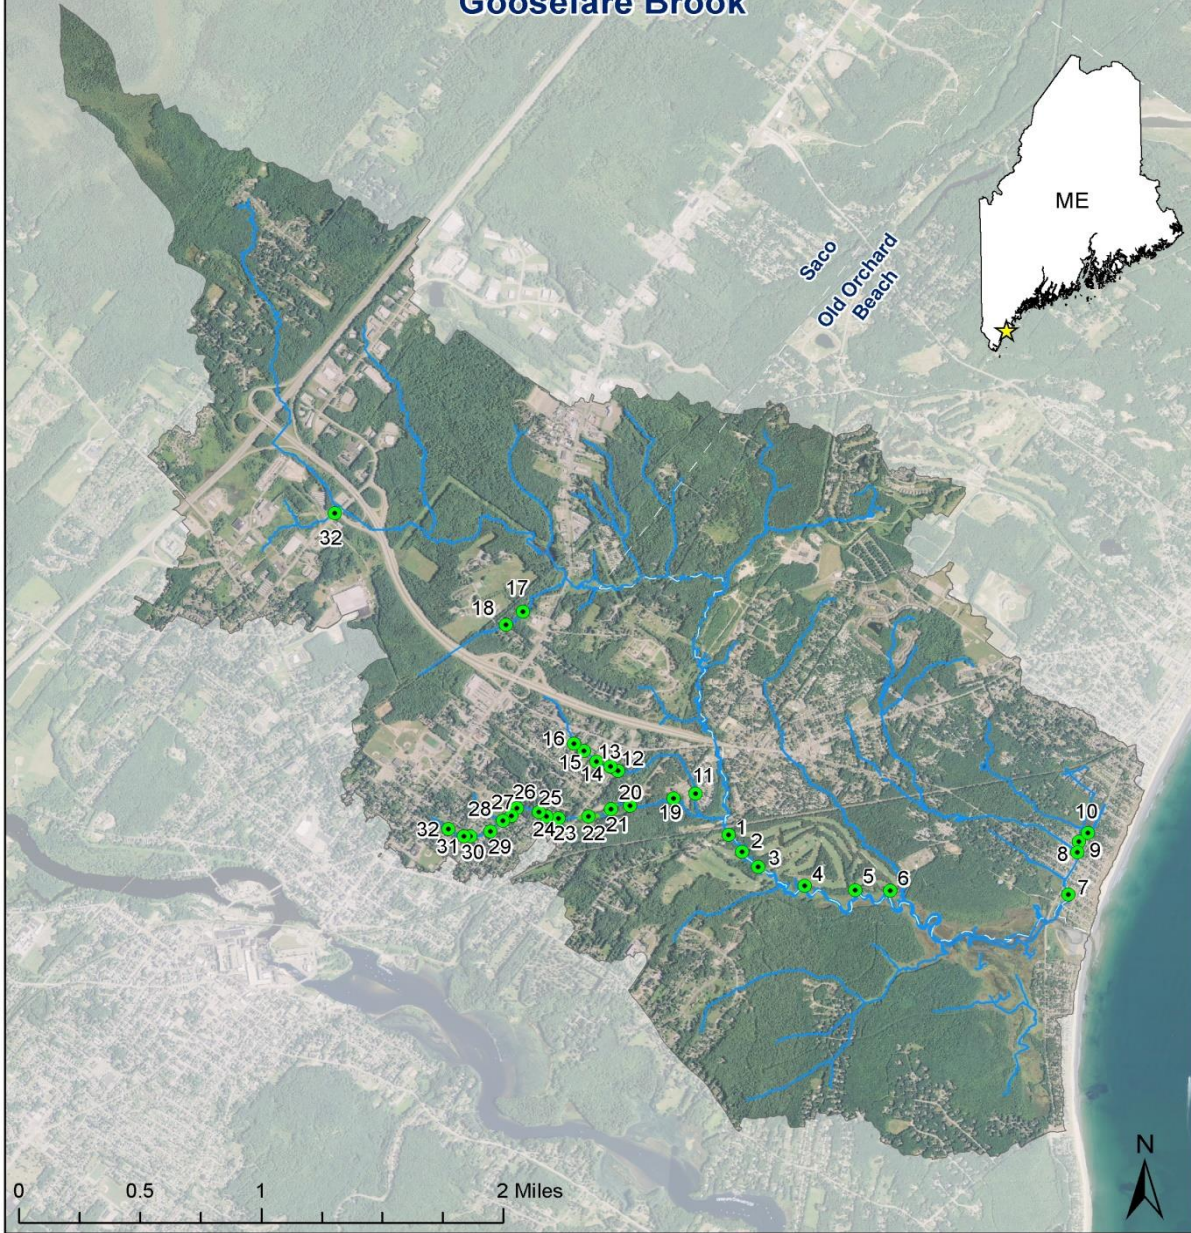
# STREAM CORRIDOR ASSESSMENT - INADEQUATE BUFFER SITES

Inadequate Buffer Points	<p><i>Data Source: Maine DEP and the Maine Office of GIS</i> <i>Projection: NAD 1983 UTM 19N</i> <i>Created by: Wendy Garland</i> <i>April 5, 2016</i></p>

**Table 8. Inadequate buffer sites** identified in the Stream Corridor Assessment. Seven additional sites were found but not prioritized and are available by request. (credit: Maine DEP)

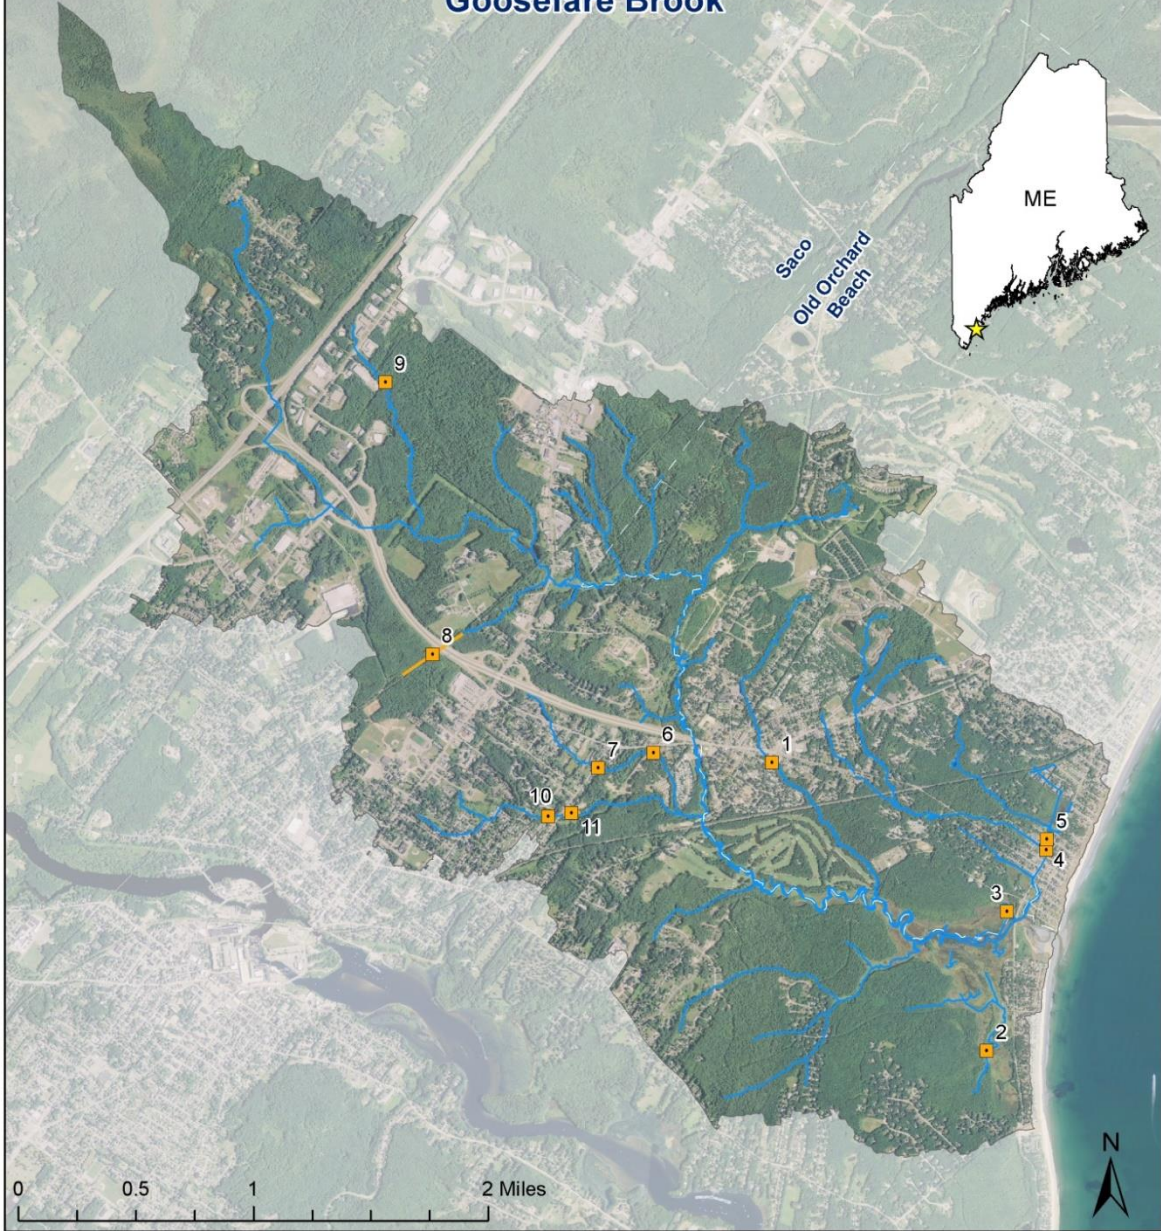
# STREAM CORRIDOR ASSESSMENT - CHANNEL ALTERATION SITES Goosefare Brook

- Channel Alteration Site
- Streams
- Towns
- Watershed

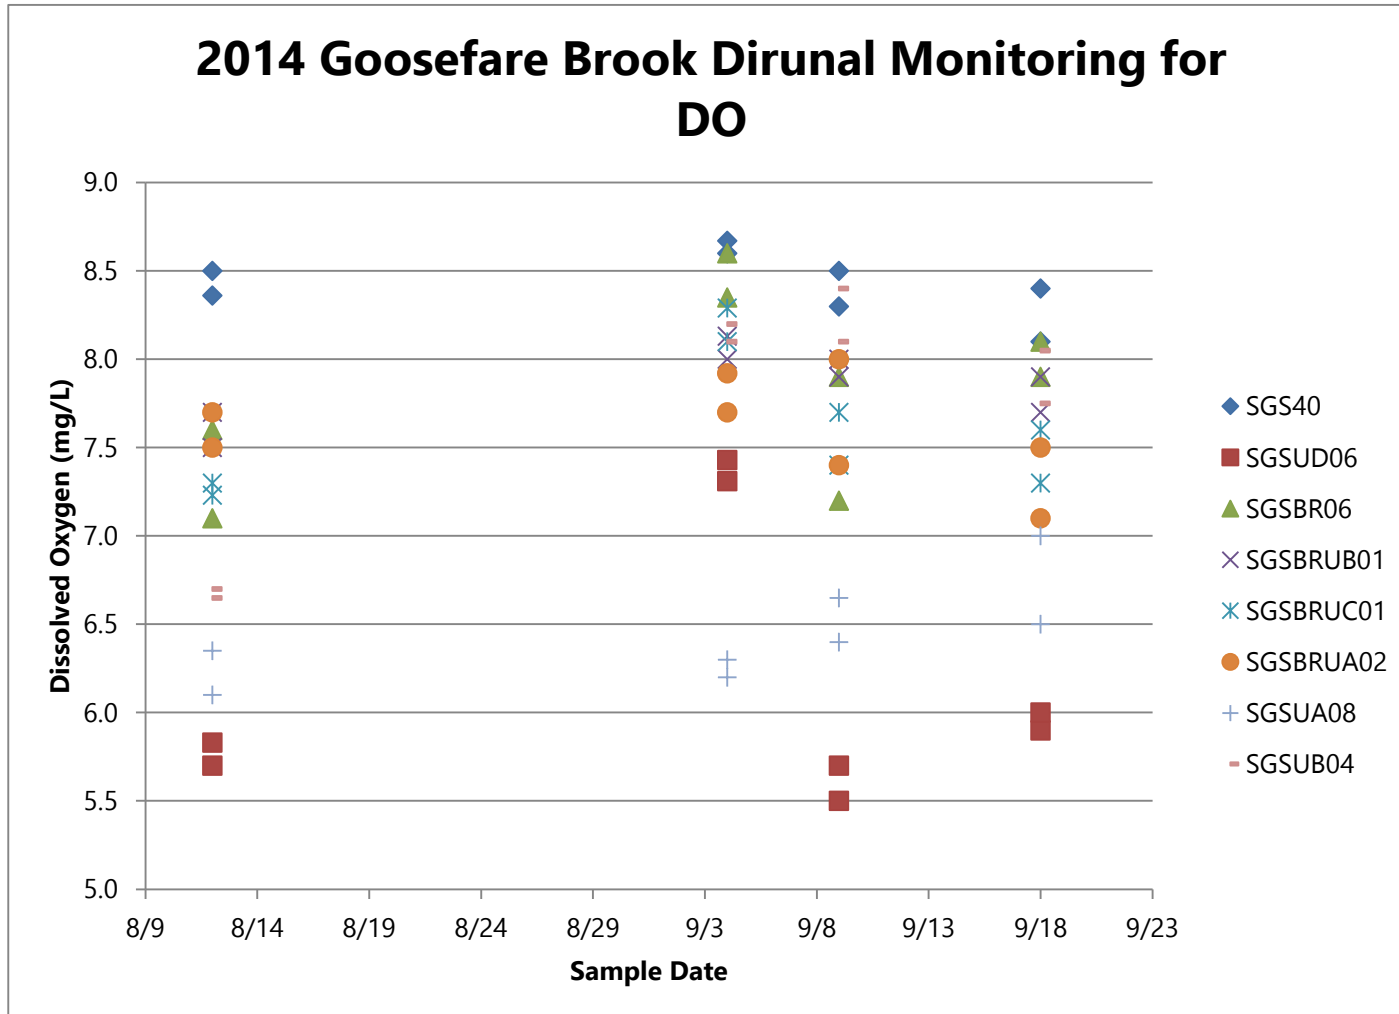
**Figure 1.** Diurnal DO monitoring conducted in 2014 by York County Soil and Water Conservation District (YCSWCD). Each site was sampled once in the morning and once in the afternoon to assess swings in DO.

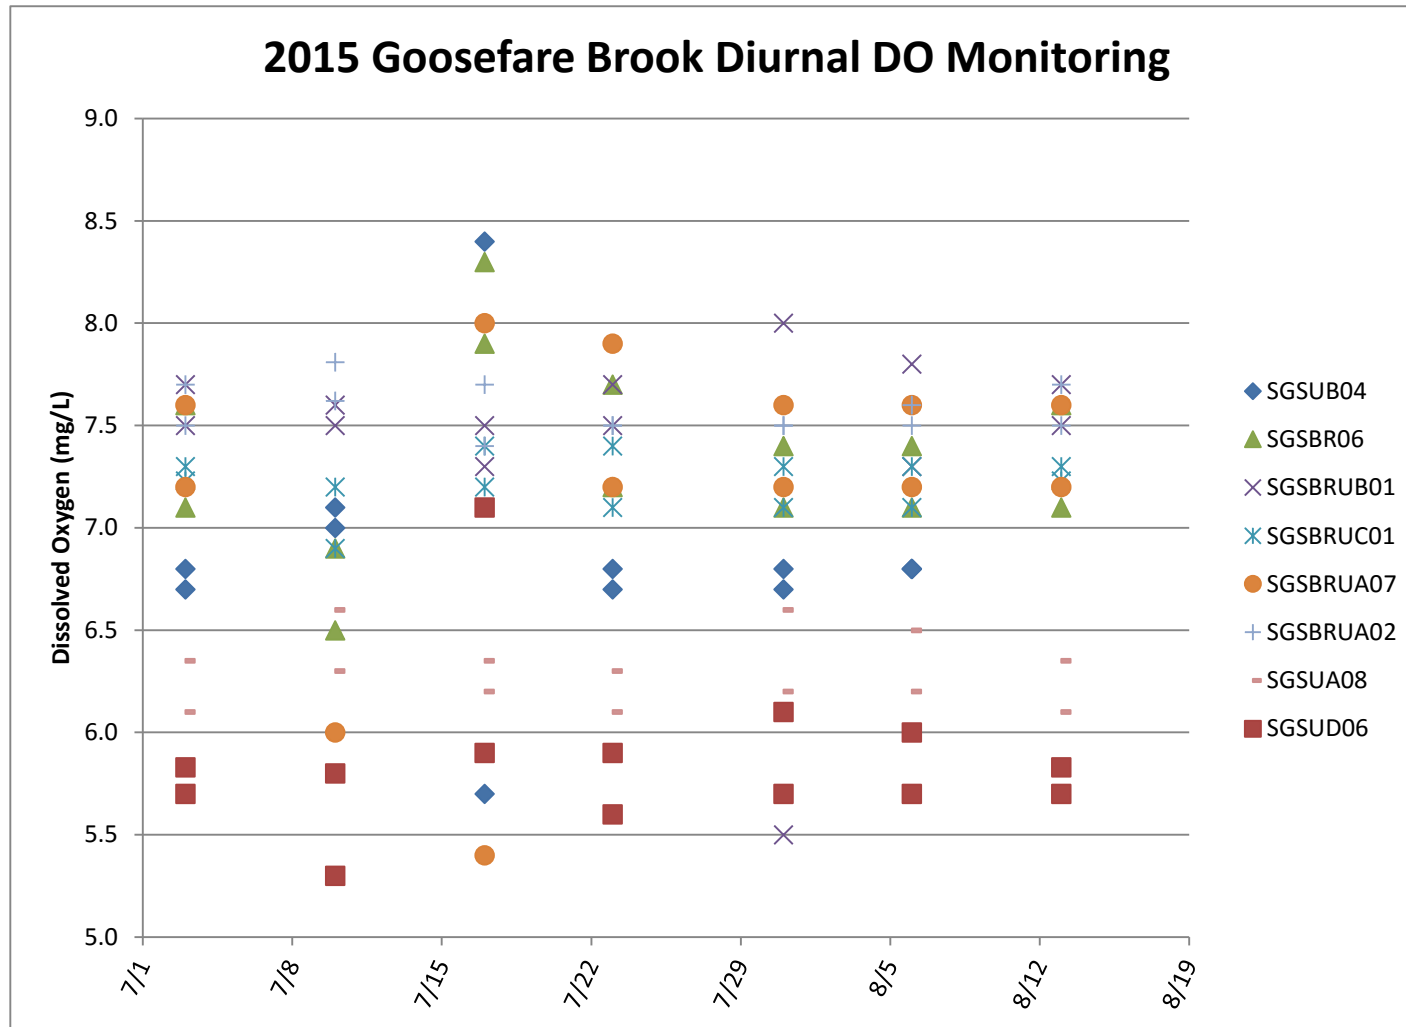
**Figure 2.** Diurnal DO monitoring conducted in 2015 by York County Soil and Water Conservation District (YCSWCD). Each site was sampled once in the morning and once in the afternoon to assess swings in DO.

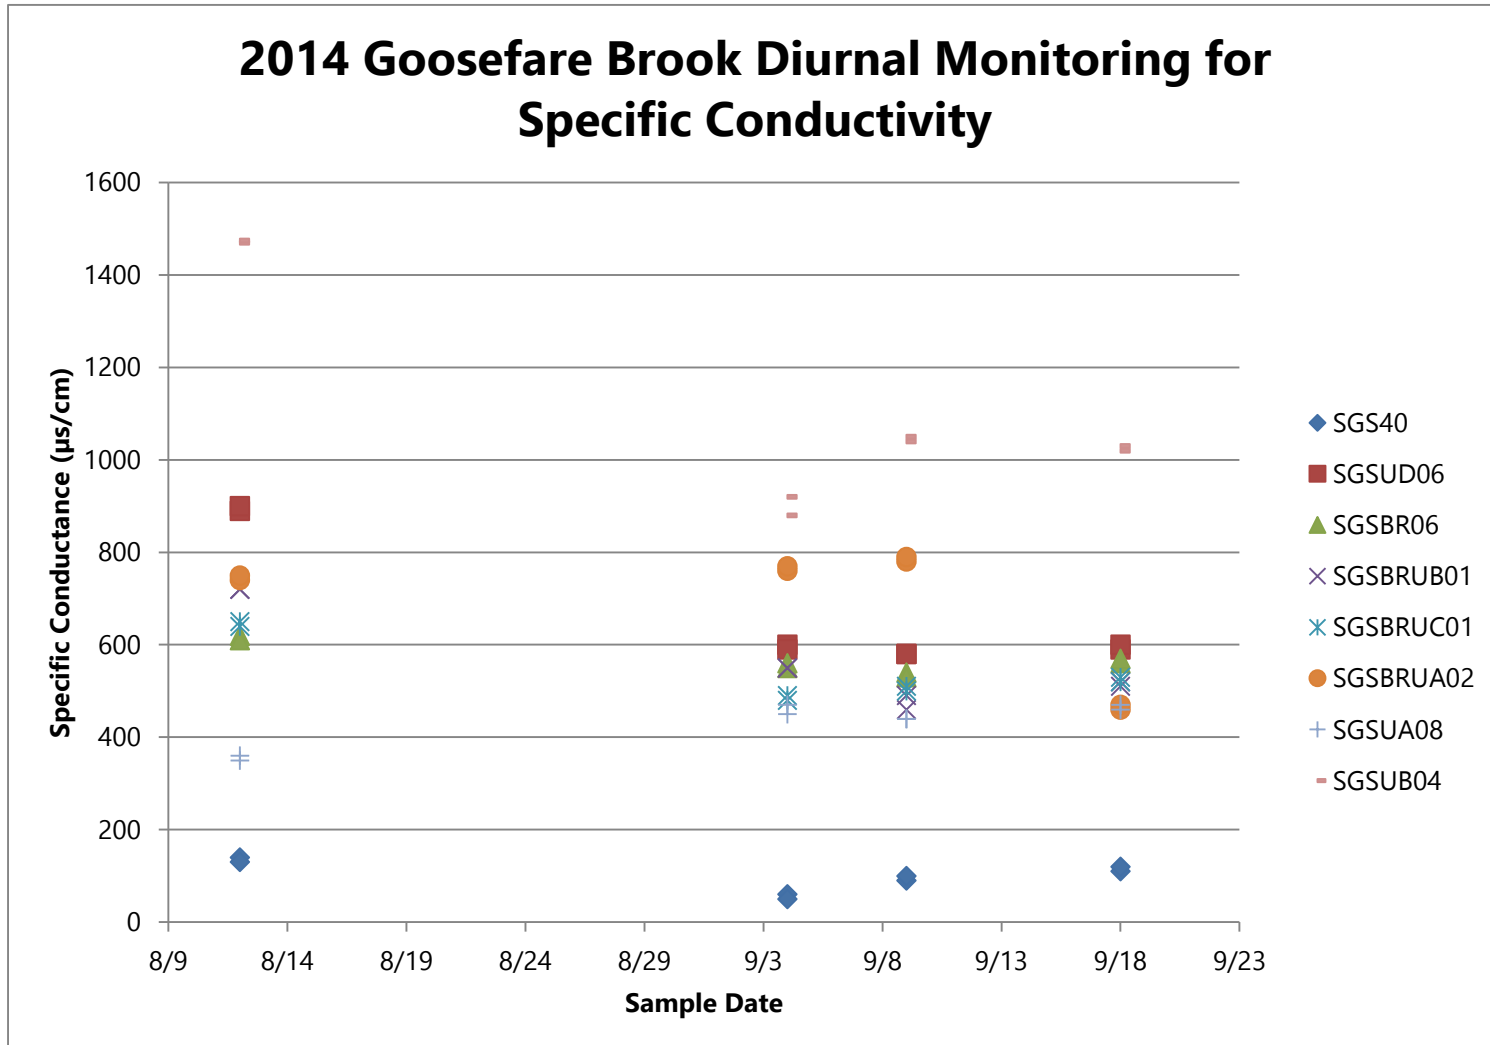
**Figure 3.** Diurnal specific conductivity monitoring conducted in 2014 by York County Soil and Water Conservation District (YCSWCD). Each site was sampled once in the morning and once in the afternoon to assess swings in specific conductivity.

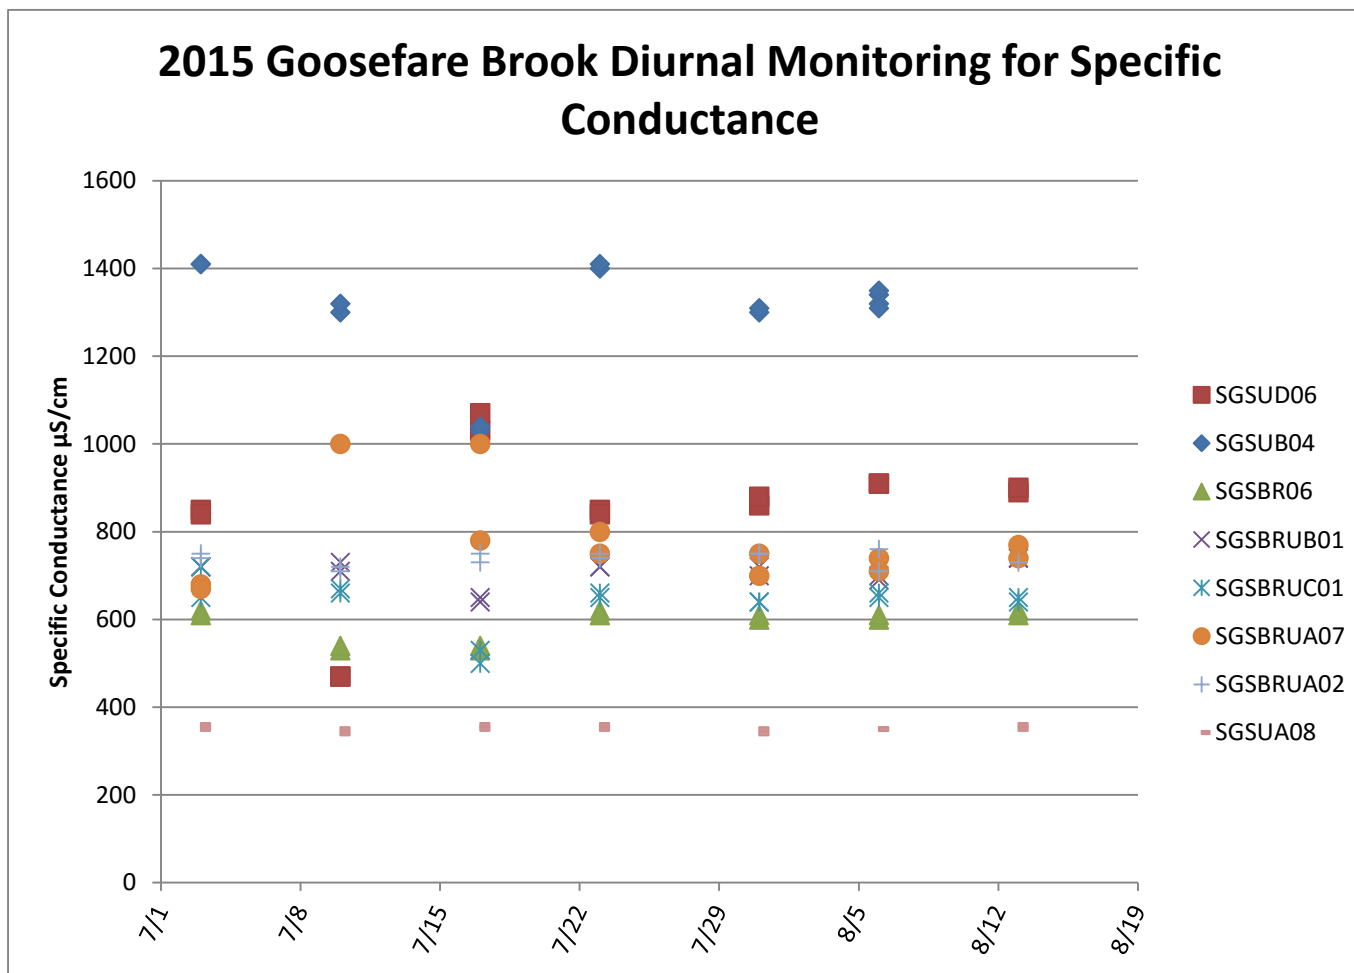
**Figure 4.** Diurnal specific conductivity monitoring conducted in 2015 by York County Soil and Water Conservation District (YCSWCD). Each site was sampled once in the morning and once in the afternoon to assess swings in specific conductivity.
